Service Report / Report

Customer: Vestdavit AS

Disassembly, inspection, and replacement of seals on Shock absorber port side on board Ramform Titan

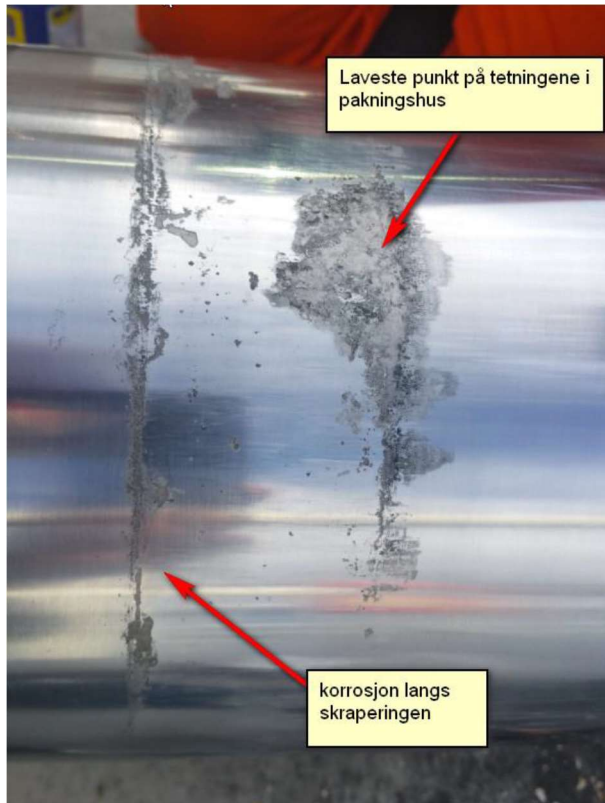
We started by draining the oil from the hydraulic cylinder. Nitrogen had been drained down to approx. 20 bar by the crew, so there was no need to drain more here. (Ref. service manual for repair of hydraulic cylinder). When the oil was pumped out, we pulled the cylinder rod out approx. half a meter for inspection. We then found large areas with fittings/corrosion on the rod in the area around the scraper ring and inwards on the seals.

Vestdavit contacted PGS to clarify whether we should continue disassembly and have the rod repaired or wait for a new rod to be purchased. At PGS's request, it was decided that we should replace the seal set in the seal housing and put the rod back. A new rod would be purchased and installed when it was delivered.

The seal set we had available on board was a repair set with split seals. This can be replaced without pulling the rod all the way out. This was installed and the cylinder was reassembled. The scraper ring was not included in the set and was therefore not replaced.
